ASSESSMENT OF THE CHURCH STREET GRAVEYARD, MOBILE, ALABAMA

Research Contribution 566

Michael Trinkley
And
Debi Hacker

September 2015

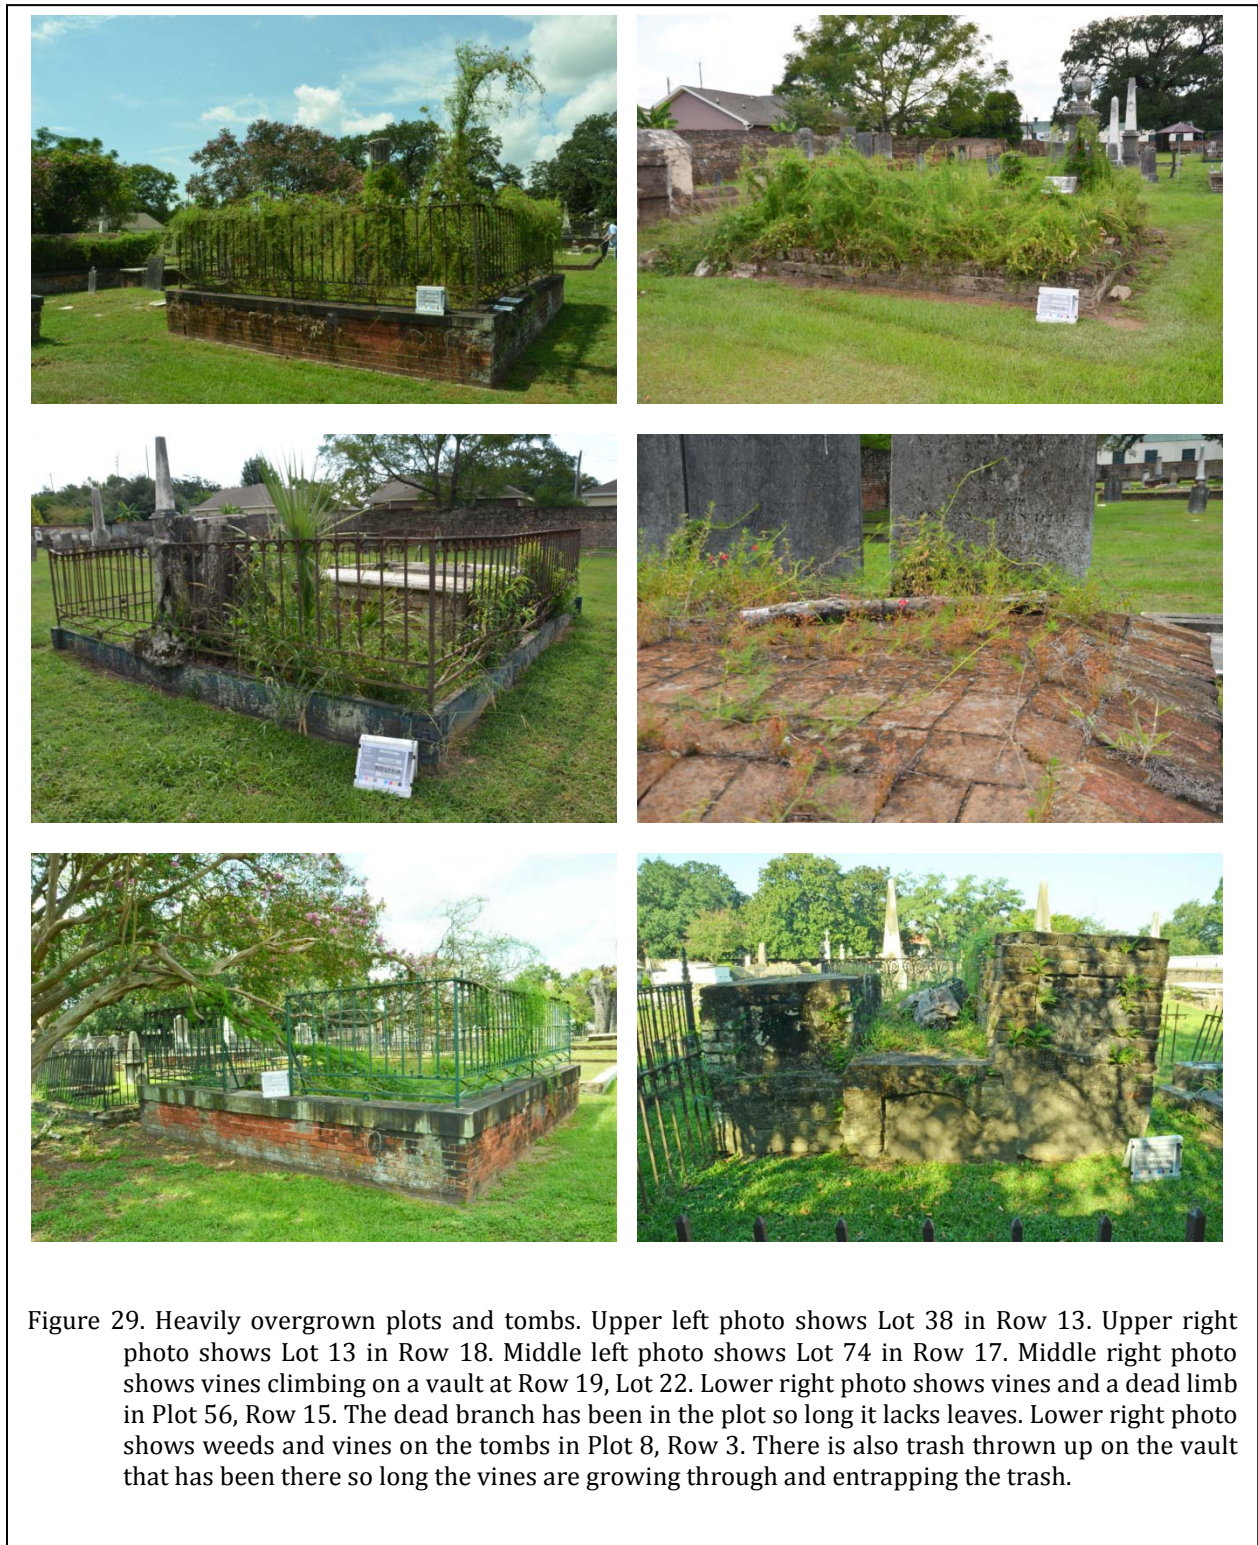
Figure 29. Heavily overgrown plots and tombs. Upper left photo shows Lot 38 in Row 13. Upper right photo shows Lot 13 in Row 18. Middle left photo shows Lot 74 in Row 17. Middle right photo shows vines climbing on a vault at Row 19, Lot 22. Lower right photo shows vines and a dead limb in Plot 56, Row 15. The dead branch has been in the plot so long it lacks leaves. Lower right photo shows weeds and vines on the tombs in Plot 8, Row 3. There is also trash thrown up on the vault that has been there so long the vines are growing through and entrapping the trash.

Where vines have taken over tombs, the appropriate treatment is to carefully remove the vines by hand (where they can be removed without causing damage to bricks or mortar joints) or be cut using sharp clippers. Where cut the remnant stub should be painted with a full-strength herbicide such as Round-up, Garlon, or Tordon to prevent their return.
